Manhole Inspection Summary

Manhole # S47MM_032MH

Insp Date: **5/8/08 1:51 PM**

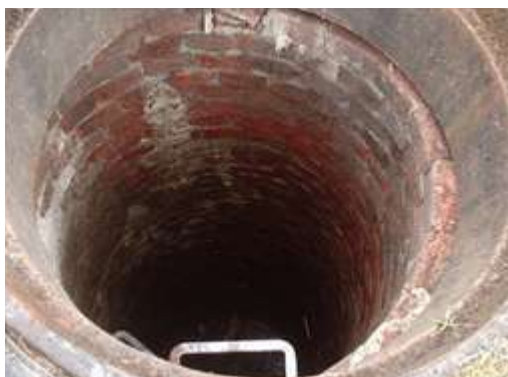
Defect 1

Condition: ☐ Sound ☐ Cracked ☐ Root Intrusion ☒ **Loose Brick** ☒ **Deteriorated**

Infiltration: ☐ None ☒ **Joint** ☐ Cracks ☒ **Mortar** ☐ Roots ☐ Wall

loose bricks

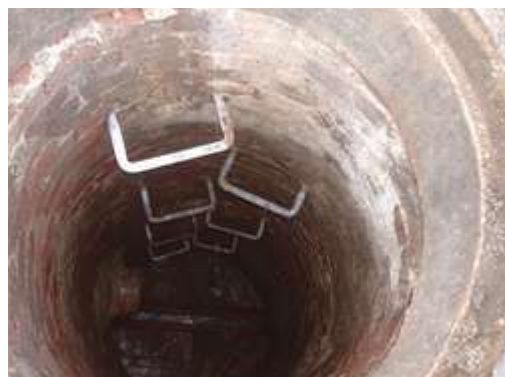
Defect 2

deterioration

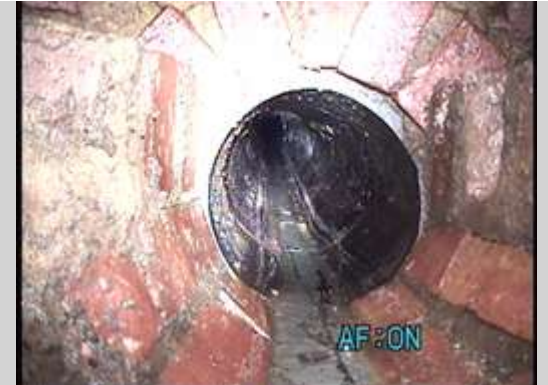
12 O'Clock Outflow

8 in. Circular Gravity Sewer
Pipe Out @ 12 O'Clock

Pipe Height: **8.4** (in.) Rod and Bar (Angled)
Pipe Material: **Clay** ☐ Pipe Lined
Invert Depth: **15.30** (ft.) Flow Characteristics: **Fast**
Deposits: ☒ None ☐ Mud ☐ Sludge ☐ Debris ☐ Grease
Silt Depth: (in.) Deposits Extent:
Infiltration: **None** Pipe Seal Cond: **Sound**

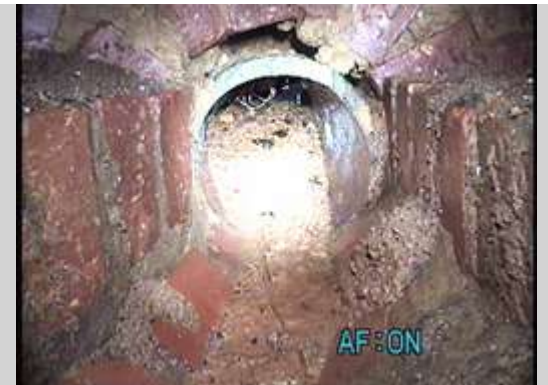
3 O'Clock Inflow

6 in. Circular Gravity Sewer
Pipe In @ 3 O'Clock

Pipe Height: **6** (in.) Rod and Bar (Angled)
Pipe Material: **Clay** ☐ Pipe Lined
Invert Depth: **14.70** (ft.) Flow Characteristics: **None**
Deposits: ☒ None ☐ Mud ☐ Sludge ☐ Debris ☐ Grease
Silt Depth: (in.) Deposits Extent:
Infiltration: **None** Pipe Seal Cond: **Sound**

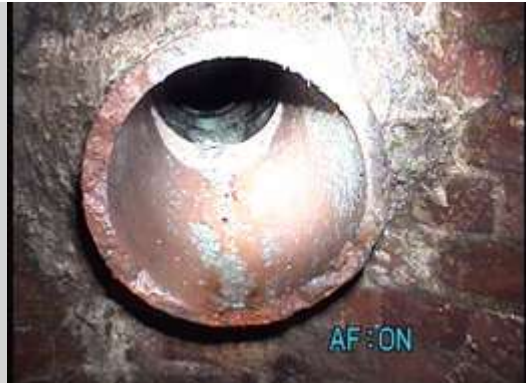
Pipe In @ 6 O'Clock

Pipe Height: **8.4** (in.) Rod and Bar (Angled)

Infiltration: **None** Pipe Seal Cond: **Sound**

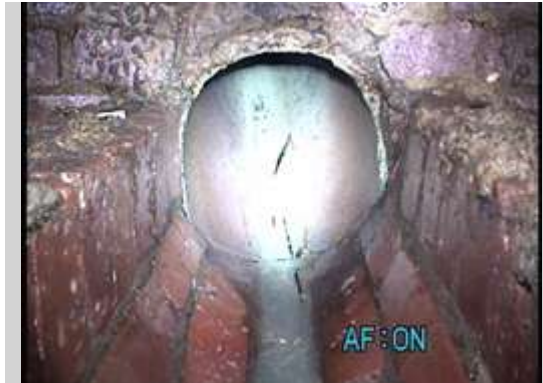
Drop In @ 6 O'Clock

Drop: Inside	Rod and Bar
Angled: Yes	Reading: 13.75 (ft.)
	Inv Depth: 14.75 (ft.)
Drop Condition: Open

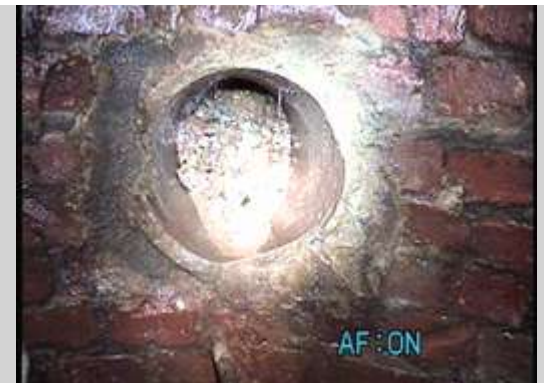
Pipe In @ 9 O'Clock

Pipe Height: **8.4** (in.) Rod and Bar (Angled)

Infiltration: **None** Pipe Seal Cond: **Sound**

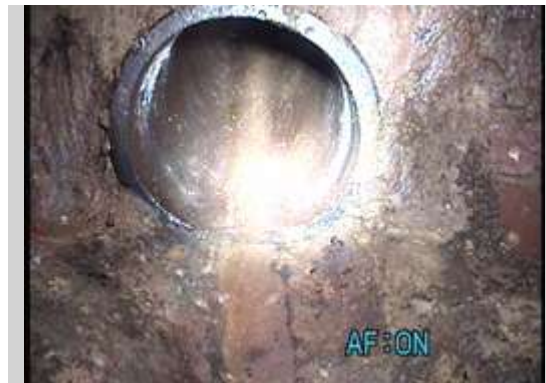
Drop In @ 9 O'Clock

Drop: Inside	Rod and Bar
Angled: Yes	Reading: 12.75 (ft.)
	Inv Depth: 13.75 (ft.)
Drop Condition: Open
